Manhole Inspection Summary

Manhole # S53U1_003MH

Insp Date: **5/29/08 2:19 PM**

Location Address: **1955 Chesapeake Ave.**

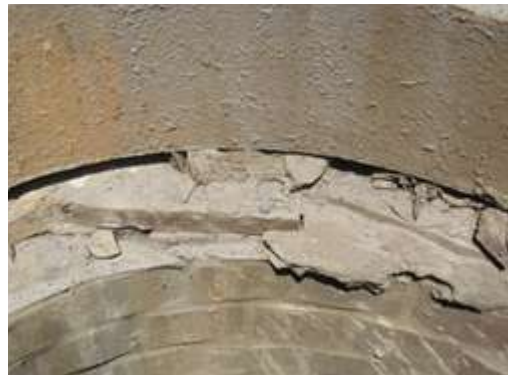
Defect 1

Condition: ☐ Sound ☐ Cracked ☐ Root Intrusion ☐ Loose Brick ☒ **Deteriorated**

Frame-Chimney joint.

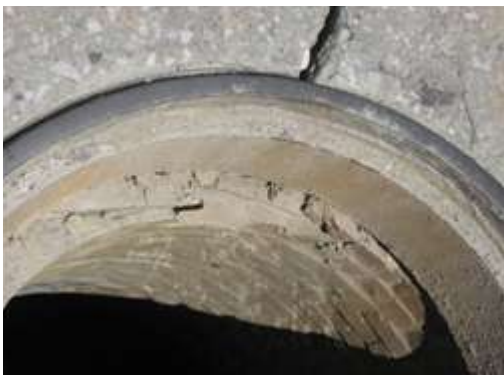
Defect 2

Offset: **2.5** (in.)

Frame offset

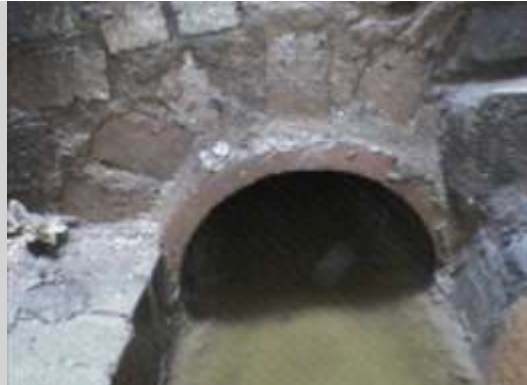
12 O'Clock Outflow

10 in. Circular Gravity Sewer
Pipe Out @ 12 O'Clock

Pipe Height: **9.6** (in.) Rod and Bar (Angled)
Pipe Material: **Clay** ☐ Pipe Lined
Invert Depth: **10.84** (ft.) Flow Characteristics: **Slow**
Deposits: ☒ None ☐ Mud ☐ Sludge ☐ Debris ☐ Grease
Silt Depth: (in.) Deposits Extent:
Infiltration: **None** Pipe Seal Cond: **Sound**

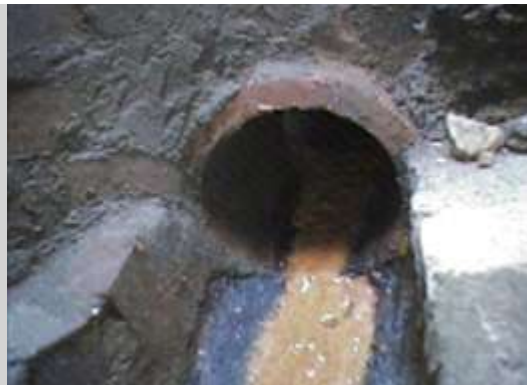
2 O'Clock Inflow

4 in. Circular Service Sewer
Pipe In @ 2 O'Clock

Pipe Height: **3.6** (in.) Rod and Bar (Angled)
Pipe Material: **Clay** ☐ Pipe Lined
Invert Depth: **1.00** (ft.) Flow Characteristics: **Fast**
Deposits: ☒ None ☐ Mud ☐ Sludge ☐ Debris ☐ Grease
Silt Depth: (in.) Deposits Extent:
Infiltration: **None** Pipe Seal Cond: **Sound**

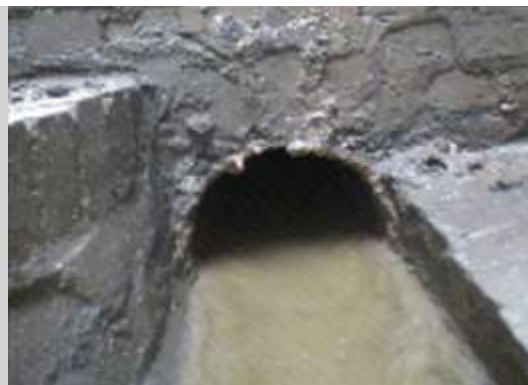
6 O'Clock Inflow

10 in. Circular Gravity Sewer
Pipe In @ 6 O'Clock

Pipe Height: **9.6** (in.) Rod and Bar (Angled)

Infiltration: **None** Pipe Seal Cond: **Sound**
